Maintenance manual Supplement:

Older Burners

This Maintenance manual supplement is approved under the authority of DOA no EASA.21J.277

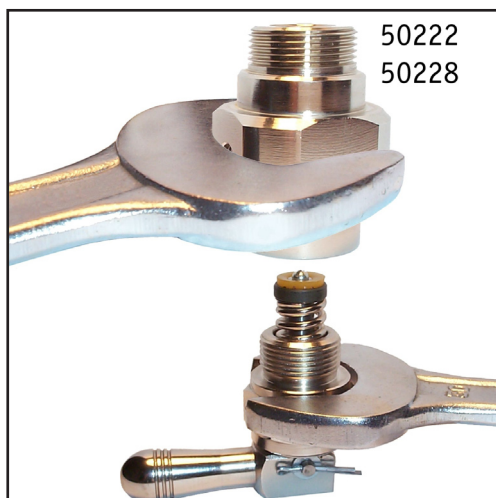
▲ Dismantling FV head of H3, H3-D and HB2 burners

- 404 - Washer, 4.3 Zn
- 413 - Pressure spring
- 420 - O-ring, 12x8 rubberý
- 422 - Washer, 3.2 Z
- 425 - Split pin, 2x18 Zn
- 50222 - Left FV body
- 50228 - Right FV body
- 50259 - Nut of FV head

Put out the nut of the main flight (blast) valve head (50259). Remove the split pin (425) with the washer (404), lever roll pin of FV head (50261), set out the lever (50263), adjusting sliding shim (50264, 50265) and carefully pick the stem (50260). The stem and bush of FV head (50262) shall be cleaned up, observed and the state of both top and bottom O-rings (420) should be checked. Protect the O-rings with silicon vaseline and if they are damaged replace them with new ones. (We recommend re-changing O-rings during every whole dismantling of the FV head). Then install the bottom O-ring firstly and put a thick layer of silicon vaseline into the room inside the head then insert the bush, the top O-ring and the lid (50267). The stem should be also coated with silicon vaseline, set the spring and install it into the head. Put together the adjusting sliding shims and the lever, put in the split pin and fix it with the roll pin (see 61-2). Complete the FV head and fix the head roll pin with the split one. Before assembling the head into the FV body (50222, 50228) check up the state of seat, face stem sealing (50520) and also the right position of the screw (423). In case you find up any damage of the sealing, replace it with new. (We recommend re-changing it during every whole dismantling of the FV head). The head should be then equipped with the seal PTFE tape of width 0.1 mm and then installed into the FV body. Check up the level clearance and conduct the leakage test with the lather solution (see Section 7.3 of the Manual).

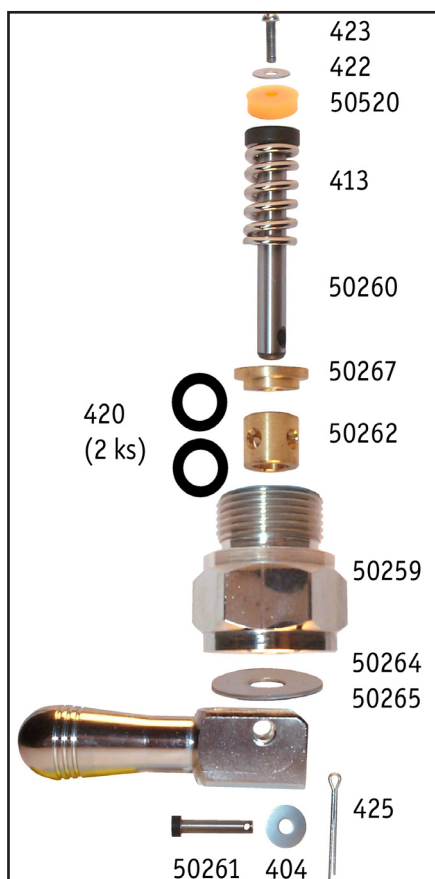
▲ FV head of H3, H3-D, HB2 burners

- 50260 - Stem of FV head
- 50261 - Lever roll pin of FV head
- 50262 - Bush of FV head
- 50263 - FV lever
- 50264 - Adjusting shim of FV
- 50265 - Adjusting shim of FV
- 50267 - Lid of FV head
- 50520 - Face seal of FV cone

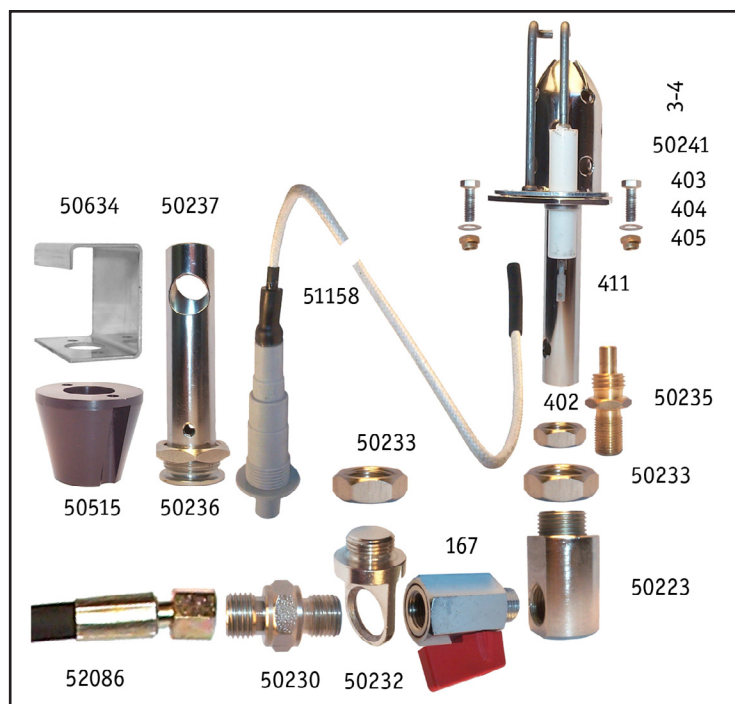
◀ Pilot burner H3, H3-D, HB2 types

- 167 - Ball cock
- 402 - Nut, M8
- 403 - Screw, M4
- 404 - Washer, 4.3
- 405 - Nut, M4
- 411 - Spark plug
- 50223 - Elbow, G1/8 - G1/4
- 50230 - Connector, M14x1,5 - G1/4
- 50232 - Support of ball cock
- 50233 - Nut, G3/8
- 50235 - Jet of PB
- 50236 - Nut M26 (H3, H3-D)
- 50237 - Cover (H3, H3-D)
- 50241 - PB body
- 50515 - Support of HB2 piezo
- 50634 - Piezo igniter cover of HB2 type
- 51158 - Piezo igniter
- 52086 - Fuel hose

Turn off the conductor (51158) from the spark ignition electrode, unscrew up the body of the pilot burner (50241) and also the jet (50235). The H3 and H3-D types need to remove the whisper burner body before unscrewing. The jet should be cleaned by using the metal wire 0.7 mm thick, then washed in petrol and dried with the pressurised cold air.

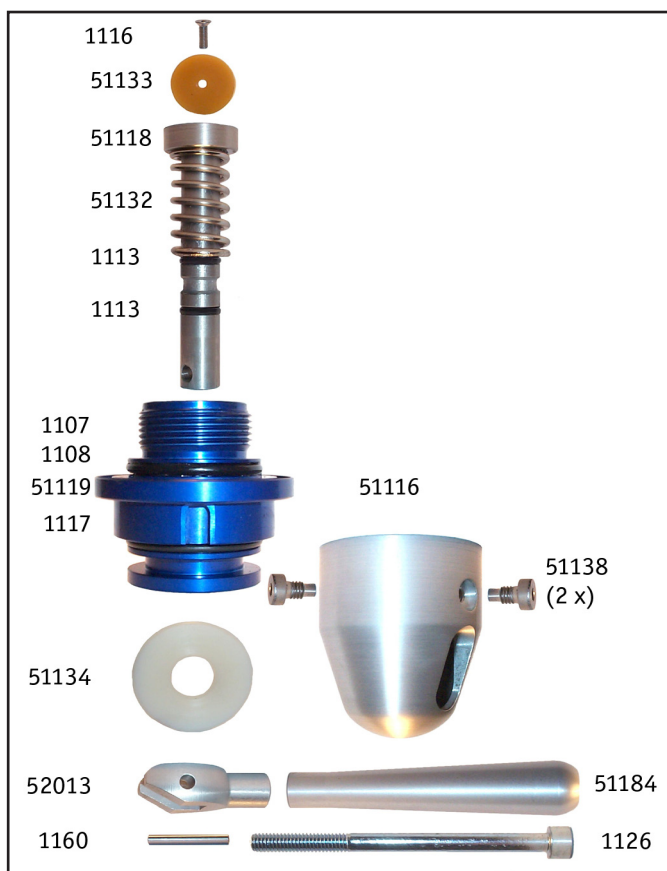
◀ Blast valve of KOMET type

- 1107 - 'O'-ring 25x2.5
- 1108 - 'O'-ring 37x2.5
- 1113 - 'O'-ring 7x1.8
- 1116 - Screw M3x8
- 1117 - 'O'-ring 25x2
- 1126 - Screw M6x80
- 1160 - Roll pin 4x28
- 51116 - Head cover of KOMET BV
- 51118 - Stem of KOMET BV/WB
- 51119 - Nut of KOMET BV
- 51132 - Spring of KOMET BV/WB
- 51133 - Stem seal of KOMET BV/WB
- 51134 - Sliding shim of KOMET burner
- 51138 - Screw of KOMET head cover
- 51184 - Lever of KOMET BV head
- 52013 - Head cam of KOMET BV

Remove the lever screw (1126) in the BV head and the screws on the head cover (51138). Remove the head cover of the BV (51116) and using a spanner unscrew the BV nut (51119). On KOMET burners S / N 105 and higher remove the head cover of WB before dismantling the BV. Then remove the screws (2722) on both units and take off the entire handle with body (52719) and cover (52718). Force out the pin (2743) and take off the lever. Using a nut wrench unscrew the BV nut. After rectifying the defects replace the damaged parts, including seals, and reassemble.

In order to replace 'O'-rings (1113) or the spring of BV (51132), first remove the roll pin (1160) from the head cam of the BV and pull out the stem of the BV (51118).

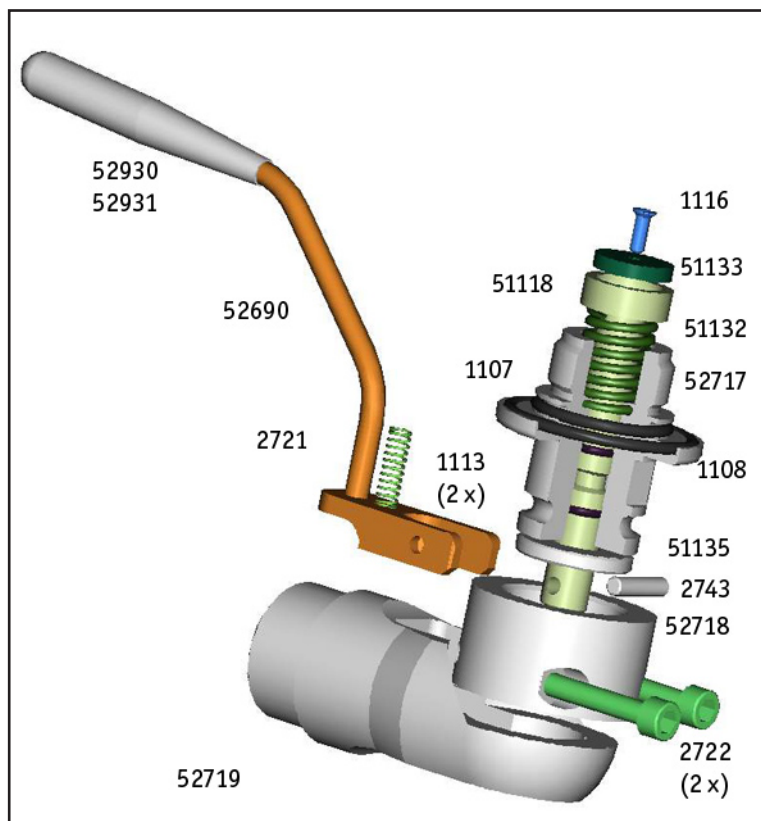
◀ Blast valve of KOMET burner
(s/n 105 and up)

- 1107 - 'O'-ring 25x2,5
- 1108 - 'O'-ring 37x2,5
- 1113 - 'O'-ring 7x1,8
- 1116 - Screw M3x8
- 2721 - Spring
- 2722 - Screw M5x35
- 2743 - Roll pin 4x16
- 51118 - Stem of KOMET BV/WB
- 51132 - Spring of KOMET BV/WB
- 51133 - Stem seal of KOMET BV/WB
- 51135 - Sliding shim of KOMET+burner
- 52690 - Lever of KOMET BV
- 52717 - Nut of KOMET BV
- 52718 - Cover of KOMET BV
- 52719 - Handle body of KOMET
- 52930 - Cover of left KOMET lever
- 52931 - Cover of right KOMET lever

Before setting the 'O'-rings (1107, 1108, 1113) into the pertinent pits, coat them carefully with lubricant. Then place the sealing of the stem and fix it with the lock screw. Slide the spring onto the stem and put a thick layer of lubricant into the space between the 'O'-rings (see 6.5.3.1). Clean the hole inside the BV nut and install the completed stem. Then put on the sliding shim (51134 or 51135) and then the head cam of the BV; adjust the openings of the sliding shim and head cam and fix in the right position with the lubricated roll pin (1160 or 2743) (see 6.5.3.1 for lubrication). Screw the complete head into the burner fitting and adjust it with of a spanner. Check that the clearance between the cam and the sliding shim is between 1 to 2 mm. If the clearance is not within these limits then change the shims for new ones of different thickness. Place the head cover with the cam on the BV nut and fix it with the screws (51138). Connect the lever of BV using the screw (1126). Check the quantity of motion, tightness and the function of the BV.

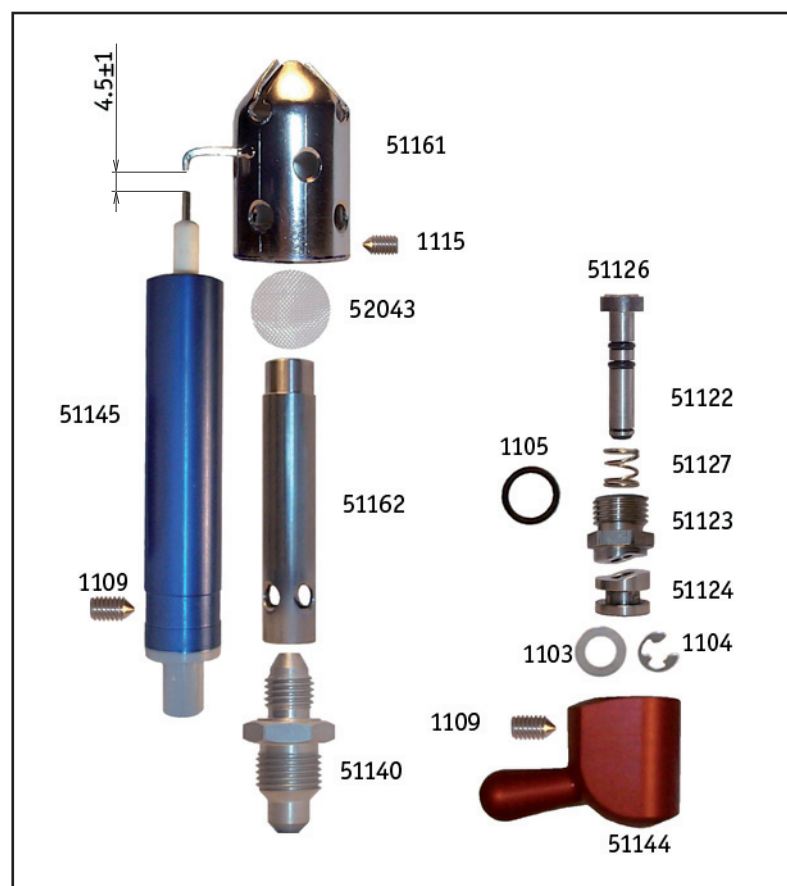
◀ KOMET pilot burner

- 1103 – Shim, 8x14
- 1104 – Safety ring on the shaft
- 1105 – 'O'-ring, 12x2.5
- 1106 – 'O'-ring, 4x1.75
- 1109 – Adjusting screw, M6x10
- 1115 – Adjusting screw, M5x8
- 51122 – Stem of KOMET PB
- 51123 – Bottom lift of KOMET PB
- 51124 – Upper lift of KOMET PB
- 51126 – Stem sealing of PB KOMET
- 51127 – Spring of PB KOMET
- 51140 – Jet of PB KOMET
- 51144 – Control lever of PB KOMET
- 51145 – KOMET piezo igniter
- 51161 – PB flame cup KOMET
- 51162 – Pipe of PB KOMET
- 52043 – Filter of PB KOMET

1. Remove the safety ring (1104), drop out the upper and bottom lifts (51124 and 51123) and pull out the stem of PB (51122) with its seals (51126).
2. Remove the safety ring (1104), drop out the upper and bottom lifts (51124 and 51123) and pull out the stem of PB (51122) with its seals (51126).
3. Loosen the lock screw (1109) and remove the pizo igniter by pulling down on the push button in its center(51144). Pull straight down so that the igniter is not damaged.
4. Loosen the lock screw (1115) and remove the PB flame cup (51161). Remove the filter and unscrew the PB pipe (51162).
5. Screw out the jet.

5. Fit the upper PB lift, shim(s) (1103) and secure with the safety ring (1104). Lubricate the stem and lift areas with Molyduval Attila GR. The clearance between the upper and bottom lift should not be more than 1mm. Set the necessary clearance by using a shim of the correct thickness.

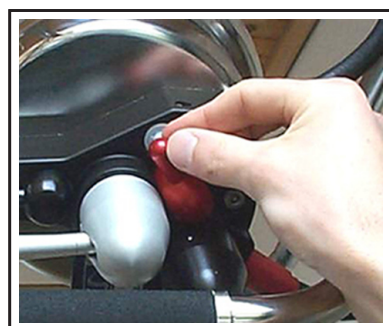
▲ Off –position (closed)

Set the On and Off positions of the control lever as shown in the pictures below. Lock the correct position by tightening the adjusting screw (1109). Check that the lever works correctly.

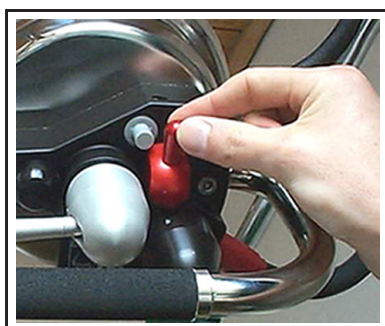
▲ Boundary between On / Off position

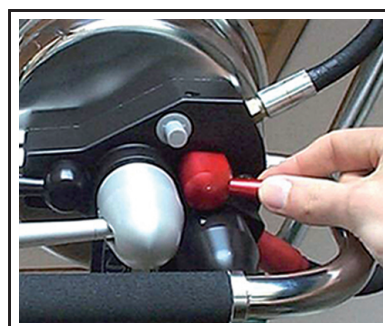
▲ On-position (open)

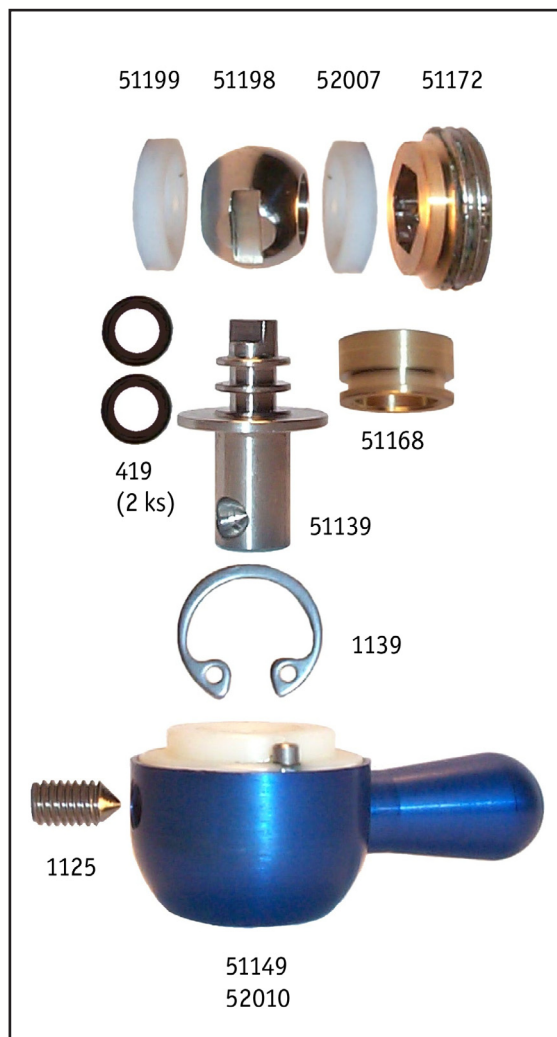
◀ Crossover valve of KOMET burner

- 419 – 'O'-ring, 6x2
- 1125 – Adjusting screw, M5x12
- 1139 – Safety ring for the hole
- 51139 – Stem of KOMET CV
- 51149 – KOMET CV control, left
- 51168 – KOMET CV casing
- 51172 – KOMET threaded shim
- 51198 – KOMET ball
- 51199 – Seat of CV I KOMET
- 52007 – Seat of CV II KOMET
- 52010 – KOMET CV control, right

A crossover valve is only used at KOMET burners of serial numbers up to 104.

Repair a fuel leak from the CV control in the following way. After disassembling CV control – crossover valve (51149, 52010), safety ring (1139) and stem replace the 'O'-rings (419). Lubricate the 'O'-rings and the space between them with lubricant (see 6.5.2.1). Fix the stem with a safety ring and secure the CV control in the correct position. If the valve does not close properly then replace the whole ball cock (parts 51172, 51198, 51199 and 52007). Disconnect the burner units and disassemble the by-passing hose of CV. Unscrew the safety nut (51172) by using an Allan key and replace the both seats and ball (51199, 52007, 51198).

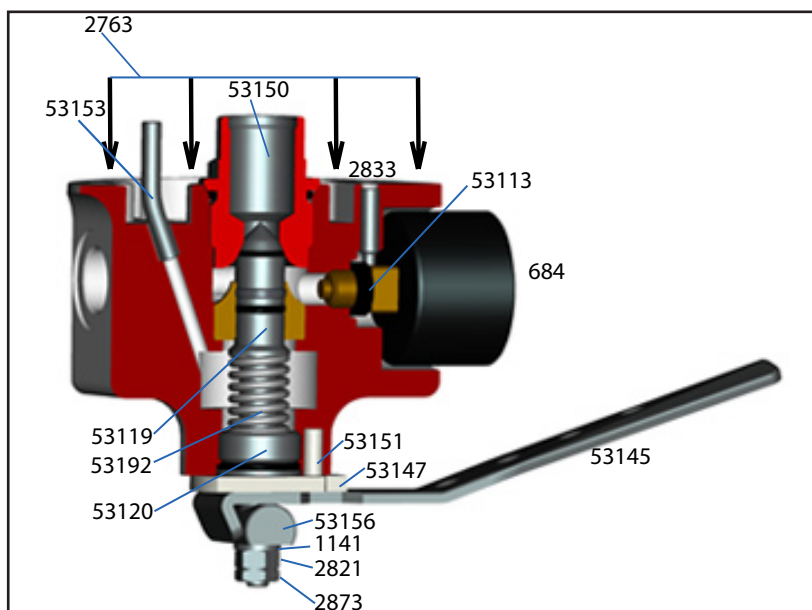
◀ Blast valve of IGNIS burner

- 684 - WIKI Manometer
- 1141 - Shim 6.4 stainless
- 2763 - Screw M5x16
- 2821 - Nut M6 stainless
- 2833 - Adjusting screw M5x20
- 2873 - Nut M6 stainless low
- 53113 - Manometer seal
- 53119 - Stem of BV
- 53120 - Screw lead of Stem BV
- 53145 - Lever of BV
- 53147 - Sliding shim
- 53150 - Threaded shim of BV
- 53151 - BV lever shock absorber
- 53153 - Blow - off tube
- 53156 - BV pendulum bearing
- 53192 - BV spring

1. Remove the screws in the burner handle, remove the handle and the cover of the lever assembly.
(For easier handling you can dismantle the fitting from the burner unit.)
2. Unscrew nuts (2873, 2821) and remove the lever assembly including the frictional sliding shim (53147).
3. Using a box spanner unscrew the lead nut (53120) and remove the stem with the spring (53119, 53192).
4. Unscrew retaining screw 2833 at least 5mm, unscrew the manometer by hand.

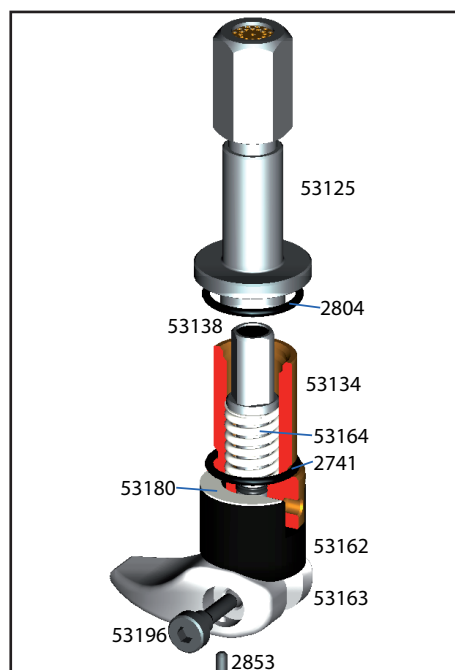
◀ Whisper burner on IGNIS burners

- 2741 – 'O'-ring, 19x2 NBR
- 2804 – 'O'-ring, 21x2 NBR
- 2853 – Adjusting screw, M3x5
- 53125 – IGNIS Whisper Burner
- 53134 – Stem casing of WB / PB
- 53138 – Stem of WB / PB
- 53162 – Lever base of WB / PB, left, right
- 53163 – Lever of WB, left, right
- 53164 – Spring of WB / PB
- 53180 – Shim
- 53196 – Lever pin of WB / PB

1. Insert the stem (53138) with the spring (53164) into the stem casing. Put the shim and lever base on the stem. Fit the WB lever (53163) and the pin (53196), tighten the pin and secure with the lock screw to prevent it rotating. Lubricate the assembly, stem and lead surface with Molyduval Attila GR.
2. Insert the assembly into the burner manifold and screw up the pressure reducer fix with the lock screw M5 and from the upper side screw up the WB unit (53125) with a seal (2804) and tighten.
3. Check there is a clearance of at least 2mm between the lever (53163) and Teflon shim. If the clearance is too large then insert more shims (53180)

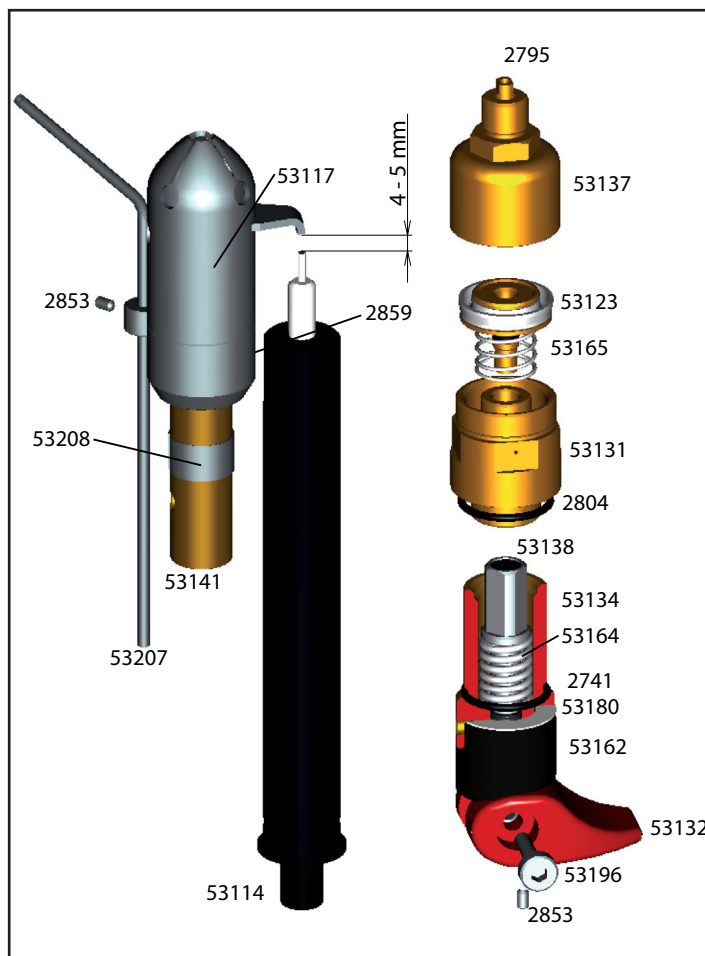
◀ IGNIS pilot burner

- 2741 – 'O'-ring, 19x2 NBR
- 2795 – Jet
- 2804 – 'O'-ring, 21x2 NBR
- 2853 – Adjusting screw, M3x5
- 2859 – Adjusting screw, M5x8
- 53114 – Piezo igniter
- 53117 – PB flame cup
- 53123 – Differential piston of PB
- 53131 – Nut of the piston chamber
- 53132 – Lever of PB, left, right
- 53134 – Stem casing of WB / PB
- 53137 – Piston chamber
- 53138 – Stem of WB / PB
- 53141 – Support of PB
- 53162 – Lever base of WB / PB, left, right
- 53164 – Spring of WB / PB
- 53165 – Piston spring
- 53180 – Shim
- 53196 – Lever pin of WB / PB
- 53207 – Tube of extractor
- 53208 – Inlet restrictor of PB

1. Loosen the lock screw of the piezo igniter and withdraw the piezo (53114).
2. Loosen the lock screw (2859) and remove the PB flame cup (53117).
3. Unscrew the pressure reducer unit by using a spanner on the flat sides of the reducer unit (53131). Prevent it rotating within the burner manifold by holding the control lever. The assembly is secured against rotation by a M5 screw (set screw), which is screwed in from the side of the fitting.
4. After unscrewing the reducer unit, unscrew the M5 safety screw and pull out the controlling assembly.
5. Before disassembling the control lever (53132) loosen the safety screw (2853). Screw out the lever pin (53196).

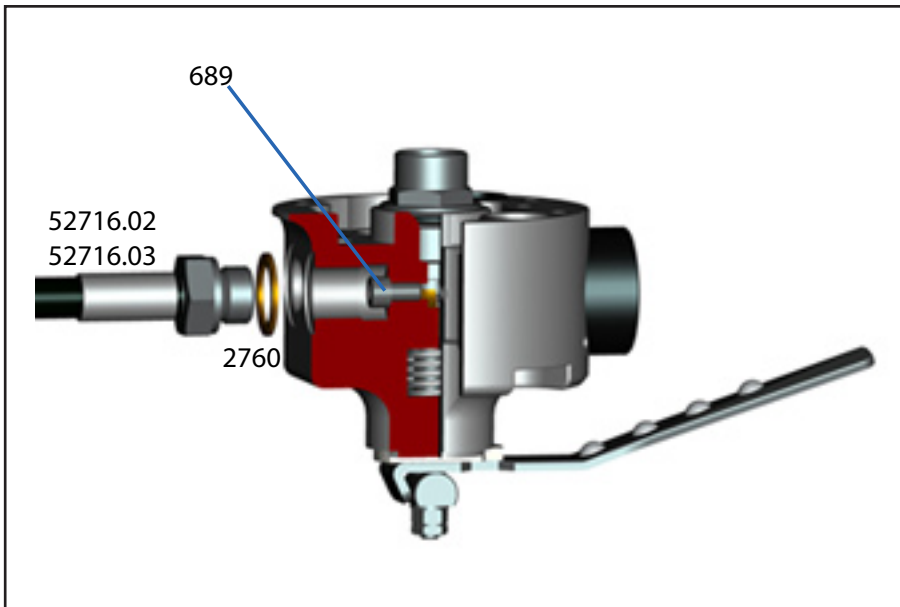
▼ Fuel supply of PB in a IGNIS without a pressure reducer (with a vapour hose)

689 – Screw, M6x10
 2760 – Sealing shim
 52716.02 – Fuel hose
 52716.03 – Fuel hose

When the burner has a vapour hose (the burner without a pressure pressure reducer) then a blinding screw (369) must be fitted in place of the fuel filter otherwise the liquid fuel would get into the vapour circuit.

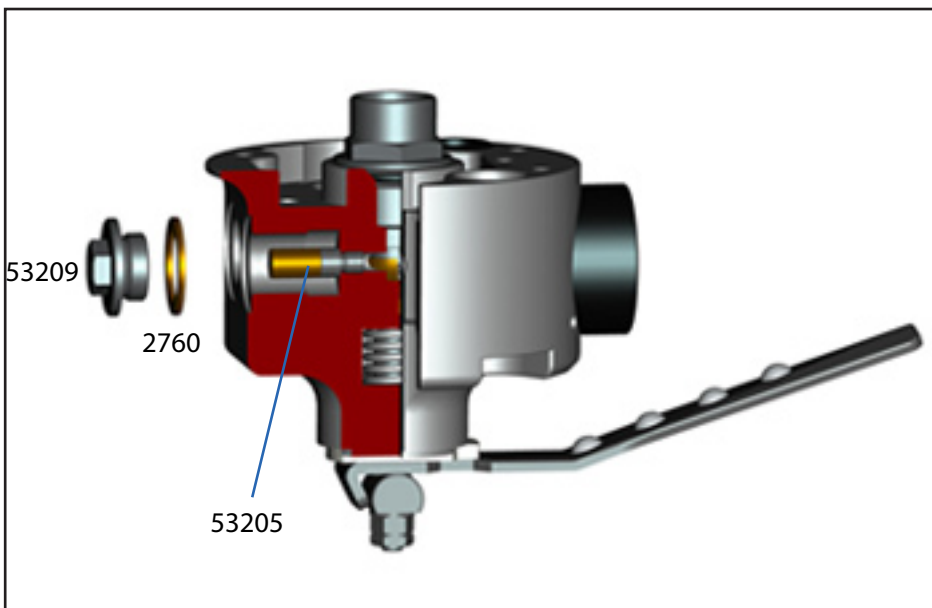
▼ Fuel supply of PB in a IGNIS with a pressure reducer (without a vapour hose)

2760 – Sealing shim
 53205 – Fuel filter II
 53209 – Plug of filter II
